**Flood Control Project Maintenance  
Levee Inspections**  
**LMA District Cover Sheet**  
**Spring 2017 Levee Inspection Results**

**Sacramento Maintenance Yard Maintenance Area 0009**

Waterway			Bank	Unit Miles
Unit No. 01 Sacramento River			Left	19.35
	Spring (March - May)	Summer (June - August)	(September - November) Fall	Winter (December - February)
Unit Maintenance Rating (Fall Only)				
Date of Inspection	4/25/2017 - 4/26/2017			
DWR Inspector	Zach Jojola			
Accompanied By	Dave Williams Sacramento Maintenance Yard

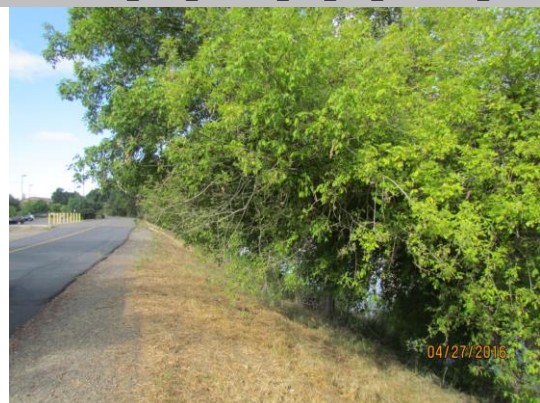
Photo 1 of 1 : SP\_2017\_MA0009\_201\_286\_20170320\_00208.jpg

View of the trees on the waterward side of the levee looking downstream. Spring 2016.

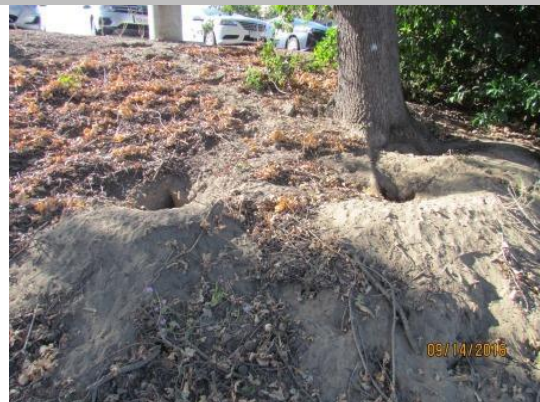
Photo 1 of 4 : SP\_2017\_MA0009\_201\_282\_20170320\_00204.jpg

LM Start	0.53	Rating **	U	Issue No.	282
LM End	0.53	Issue Type +	Ma	Location *	WS
Category	Earthen Levee			GPS Latitude/Longitude	
				Start	End
Item	Animal Control			38.534930 °	38.534930 °
				-121.517314 °	-121.517314 °
DWR ID	DWR_MA0009_01_f_2015_282				
Comment Code					
A1 : Exterminate rodents and backfill and compact or grout burrows.					
Inspector Comment					
More animal burrows were found during Fall 2016 inspection.

View of rodent holes on the waterside slope of the levee. Fall 2016

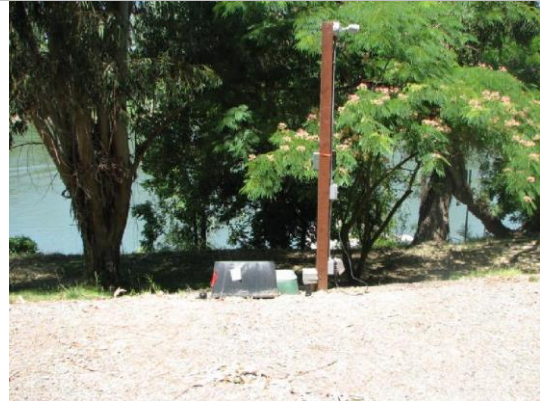
Photo 3 of 3 : UCIP\_SP\_2017\_5844\_8912.jpg

Light on Pole WS slope.

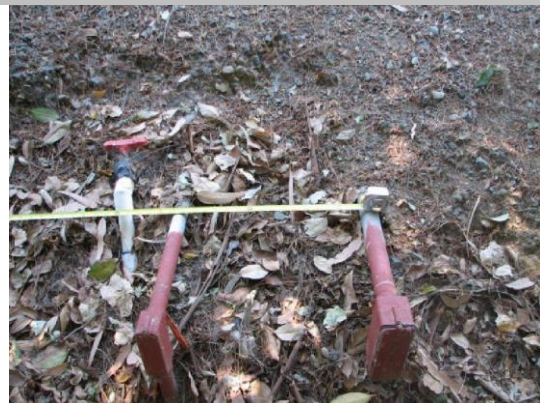
Photo 1 of 2 : UCIP\_SP\_2017\_5845\_8916.jpg

LM Start	0.98	Rating **	M	Issue No.	1777
LM End	0.98	Issue Type +	En	Location *	WS
Category	Supplemental			GPS Latitude/Longitude	
				Start	End
Item	DWR UCIP Field Study			38.532150 °	38.532150 °
				-121.524660 °	-121.524660 °
DWR ID					
Comment Code					
Inspector Comment					
FS_ID:5845 DS_ID:18899 EP_NO: N/A Repair Type: Non-Urgent Crossing Status: Found UCIP Comments: No permit identified for this crossing. FIELD_STRUCT_DESC: 1.0-inch PVC water line through the levee, 1.5 feet below the crown. Shutoff valve on landside shoulder. Light on pole next to irrigation box on waterside shoulder. FS Date: 6/19/2012 9:32:28 AM

Pipes with shutoff valve on LS slope.

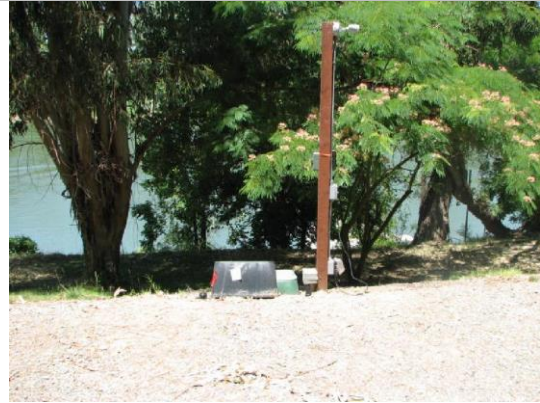
Photo 2 of 2 : UCIP\_SP\_2017\_5845\_8915.jpg

WS slope showing christie box on surface with waterline under box at downstream side of light post.

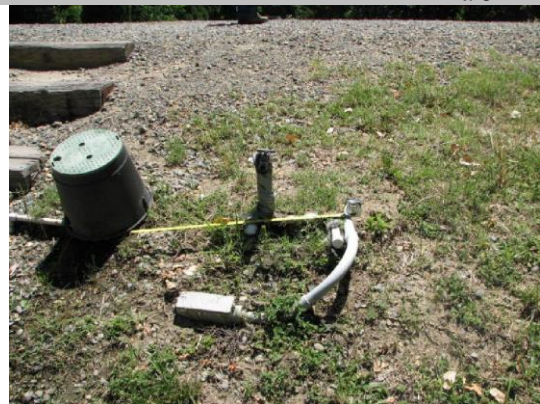
Photo 1 of 3 : UCIP\_SP\_2017\_5848\_8921.jpg

Hose bib on WS slope downstream 2-feet from stairs.

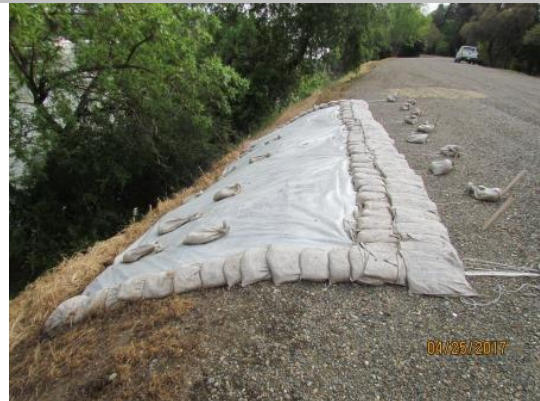
Photo 1 of 1 : SP\_2017\_MA0009\_201\_263\_20170426\_00501.jpg

LM Start	1.13	Rating **	M	Issue No.	263
LM End	1.13	Issue Type +	Ma	Location *	WS
Category	Earthen Levee			GPS Latitude/Longitude	
				Start	End
Item	Erosion / Bank Caving			38.531293 °	38.531293 °
				-121.527303 °	-121.527303 °
DWR ID	DWR_MA0009_01_s_2017_263				
Comment Code					
E2 : Schedule repair of erosion site prior to the next inspection.					
Inspector Comment					
Erosion on waterside levee slope. LMA placed envelope to prevent further damage from occurring.

View of erosion and envelope on waterside slope. Spring 2017.

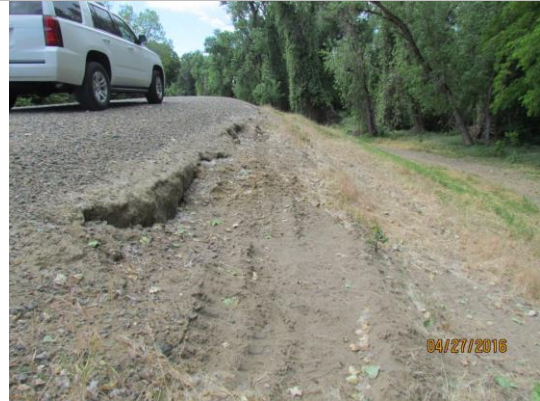
Photo 2 of 2 : SP\_2017\_MA0009\_201\_312\_20170320\_00232.jpg

View of the erosion on the waterward side of the levee looking downstream. Erosion is on below the shoulder of the levee. Spring 2016.

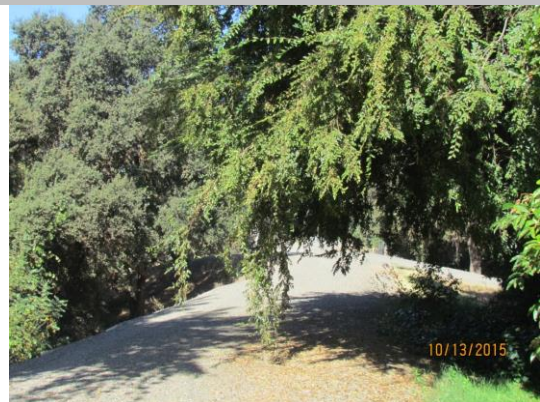
Photo 1 of 1 : SP\_2017\_MA0009\_201\_316\_20170320\_00234.jpg

View of the tree on the crown of the levee looking upstream. Fall 2015.

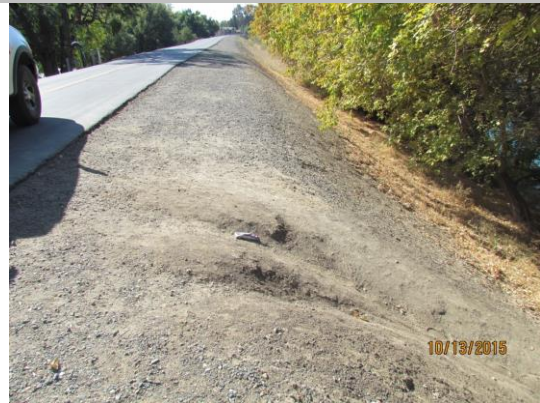
Photo 1 of 1 : SP\_2017\_MA0009\_201\_318\_20170320\_00238.jpg

View of the slope stability on the waterward side of the levee looking downstream. Fall 2015.

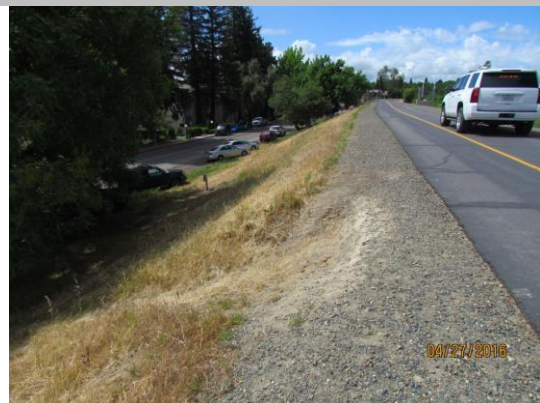
Photo 1 of 1 : SP\_2017\_MA0009\_201\_319\_20170320\_00239.jpg

View of the slope stability on the landward side of the levee looking downstream. Spring 2016.

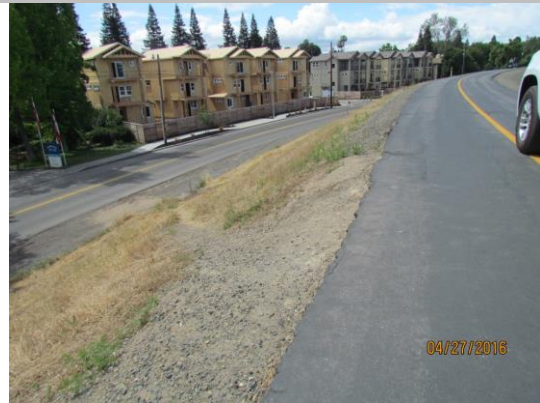
Photo 1 of 1 : SP\_2017\_MA0009\_201\_313\_20170320\_00233.jpg

View of the slope stability on the landward side of the levee looking downstream. Spring 2016.

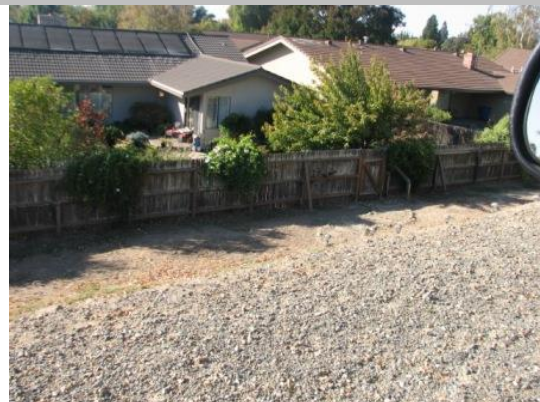
Photo 1 of 1 : SP\_2017\_MA0009\_201\_35\_20170320\_00029.jpg

A wooden fence is within the easement. Fall 2013

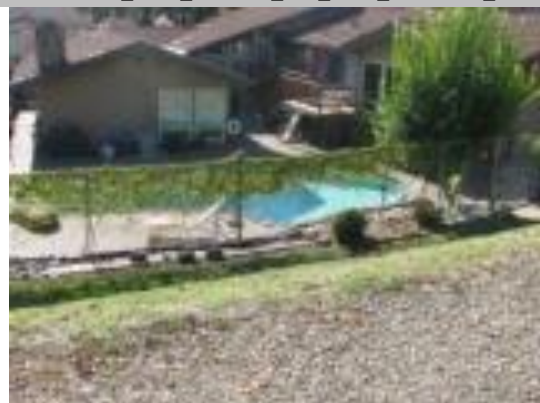
Photo 1 of 1 : SP\_2017\_MA0009\_201\_1254\_20170320\_00302.jpg

Pool and retaining wall in the easement. Fall 2012

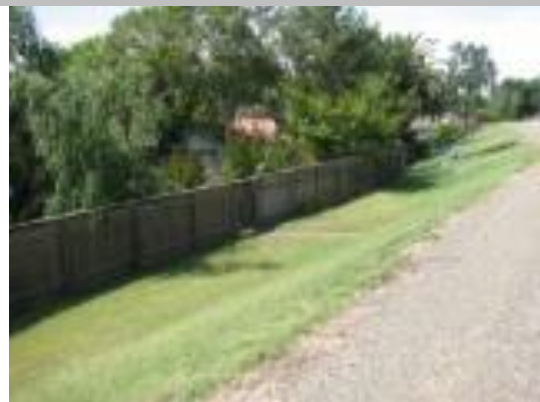
Photo 1 of 1 : SP\_2017\_MA0009\_201\_58\_20170320\_00042.jpg

Several homes have solid fences and make it hard to see.

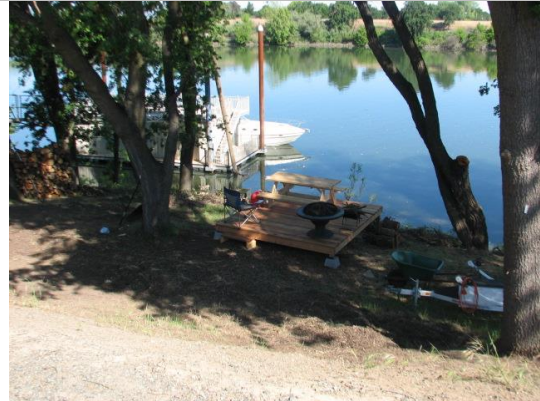
Photo 3 of 3 : SP\_2017\_MA0009\_201\_299\_20170320\_00219.jpg

A new deck has been added to the waterside berm. Spring 2014

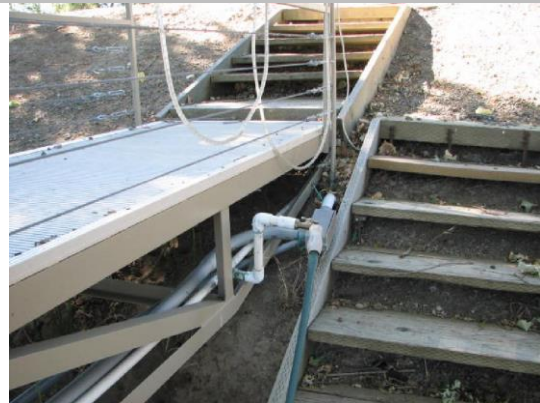
Photo 1 of 2 : UCIP\_SP\_2017\_5860\_8946.jpg

Pipes visible on downstream side of pier walkway.

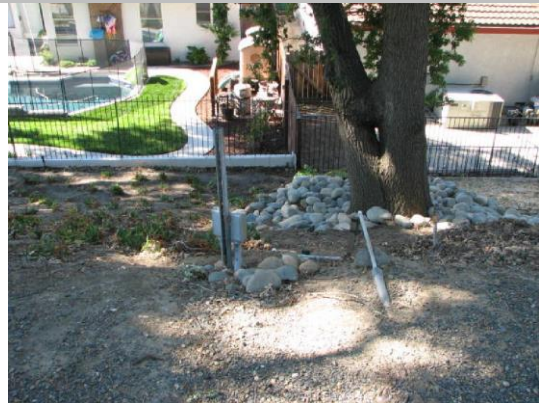
Photo 1 of 2 : UCIP\_SP\_2017\_5856\_8938.jpg

Galvanized steel pipe with pvc electrical conduit running through it, LS shoulder 50-feet downstream from pier/ramp.

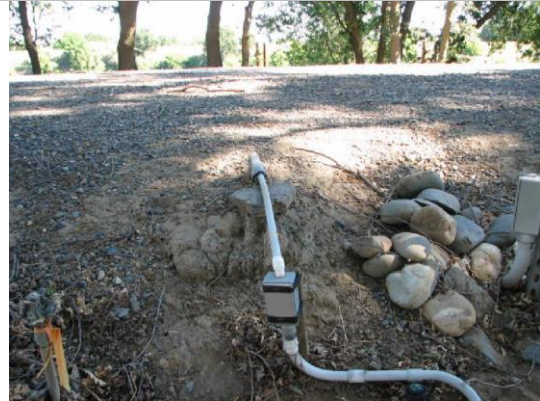
Photo 2 of 2 : UCIP\_SP\_2017\_5856\_8937.jpg

Galvanized steel pipe with pvc electrical conduit running through it, LS shoulder 50-feet downstream from pier/ramp.

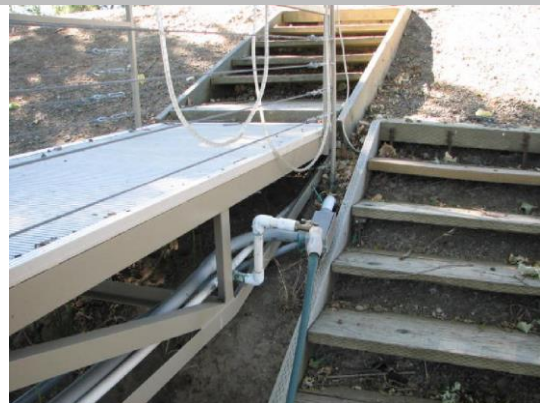
Photo 1 of 2 : UCIP\_SP\_2017\_5854\_8934.jpg

Pipes at downstream side of walkway/pier on WS slope.

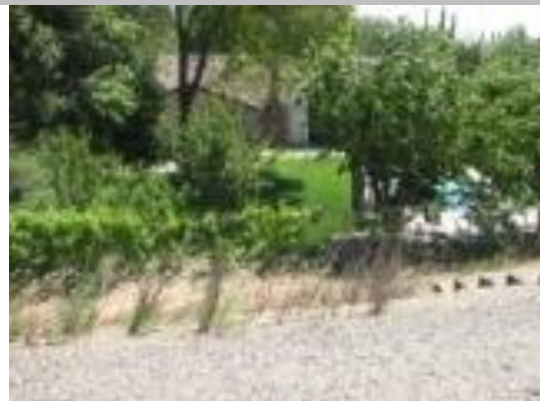
Photo 1 of 1 : SP\_2017\_MA0009\_201\_195\_20170320\_00159.jpg

Fence with grape vines growing on it. Spring 2013

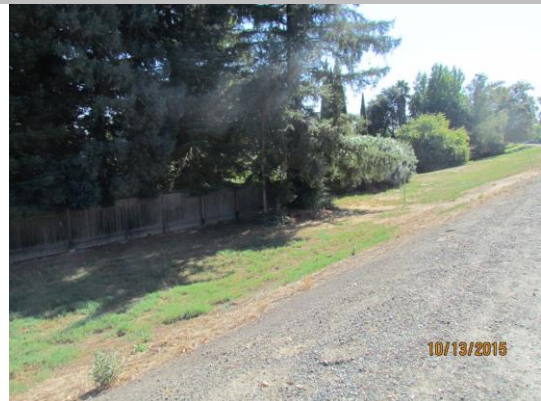
Photo 2 of 2 : SP\_2017\_MA0009\_201\_108\_20170320\_00073.jpg

View of the fence on the landward side of the levee looking downstream. Fall 2015.

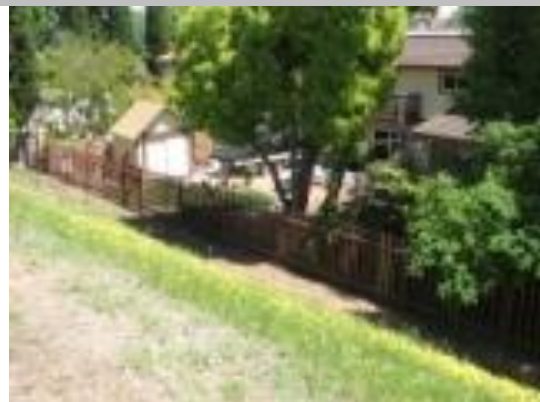
Photo 1 of 1 : SP\_2017\_MA0009\_201\_120\_20170320\_00079.jpg

Steps with handrail, fence and landscape with garden shed. Spring 2013

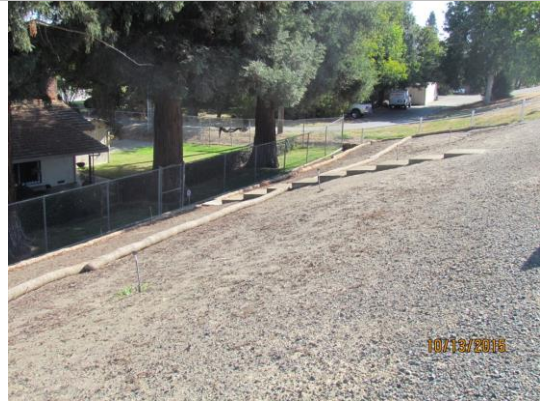
Photo 1 of 1 : SP\_2017\_MA0009\_201\_129\_20170320\_00087.jpg

View of the steps, fence and large trees at the toe of the levee on the landward side looking downstream. Fall 2015.

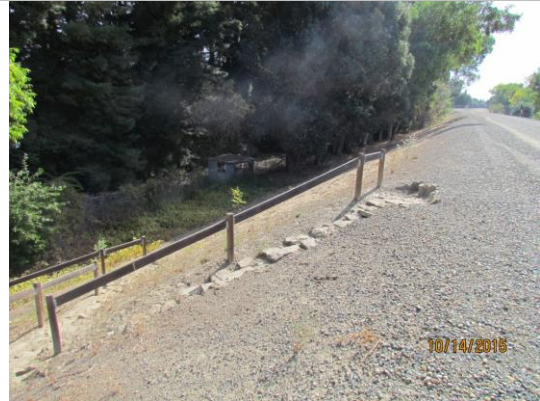
Photo 1 of 1 : SP\_2017\_MA0009\_201\_146\_20170320\_00106.jpg

View of the landscaping along the toe of the levee on the landward side looking downstream. Fall 2015.

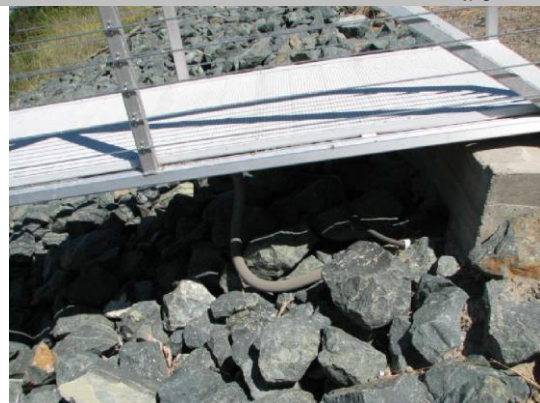
Photo 1 of 2 : UCIP\_SP\_2017\_5900\_8962.jpg

Pipes under walkway on WS at ramp.

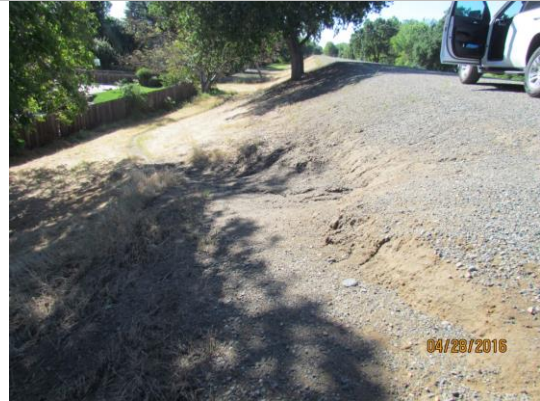
Photo 2 of 2 : SP\_2017\_MA0009\_201\_358\_20170320\_00272.jpg

View of the slope stability on the landward side of the levee looking downstream. Spring 2016.

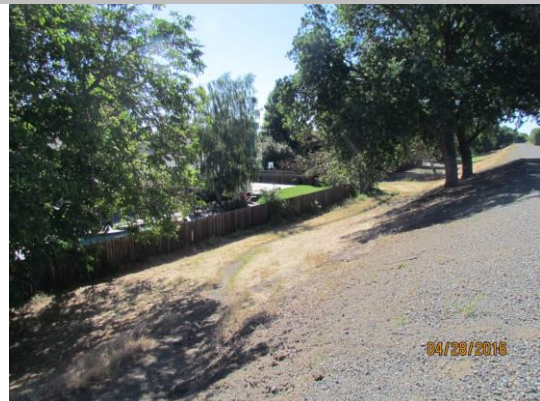
Photo 1 of 1 : SP\_2017\_MA0009\_201\_153\_20170320\_00113.jpg

View of the the wooden fence at the toe of the levee on the landward side looking downstream. Spring 2016.

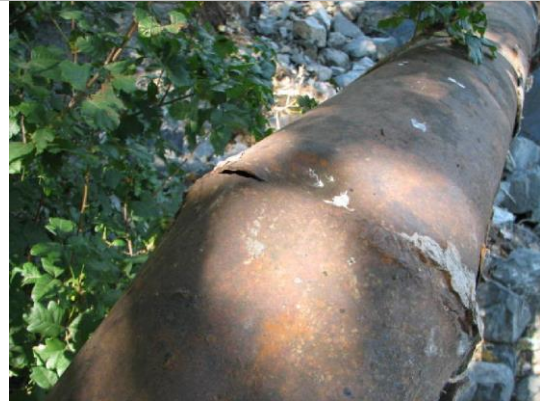
Photo 3 of 3 : UCIP\_SP\_2017\_4980\_6628.jpg

small holes in pipe along welded seam.

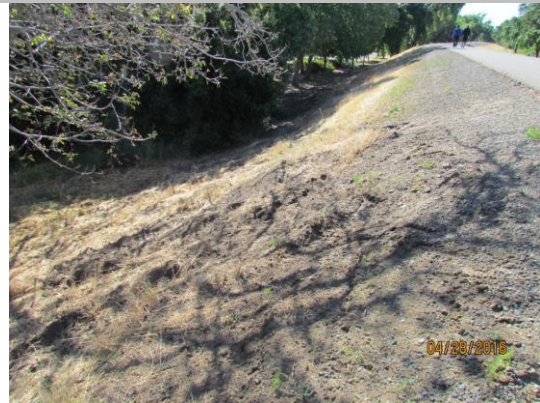
Photo 1 of 1 : SP\_2017\_MA0009\_201\_369\_20170320\_00287.jpg

View of the slope stability caused by vehicles on the landward side of the levee looking downstream. Spring 2016.

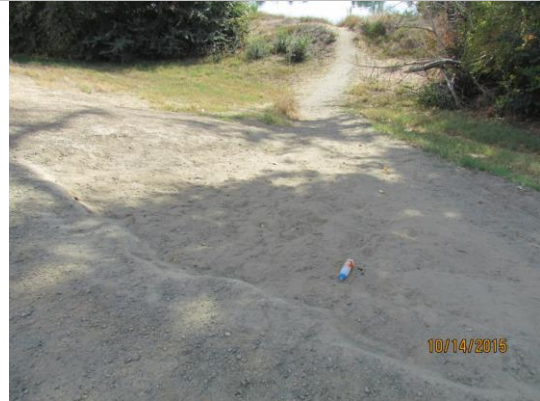
Photo 3 of 3 : SP\_2017\_MA0009\_201\_301\_20170320\_00225.jpg

Looking at the trail caused by foot traffic. Fall 2015.

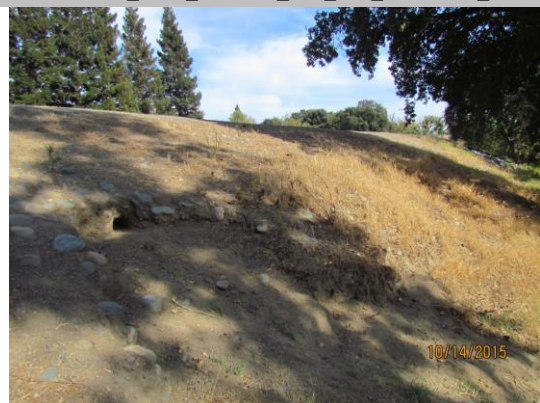
Photo 1 of 1 : SP\_2017\_MA0009\_201\_341\_20170320\_00262.jpg

View of the slope stability caused by foot traffic on the waterward side of the levee looking downstream. Fall 2015.

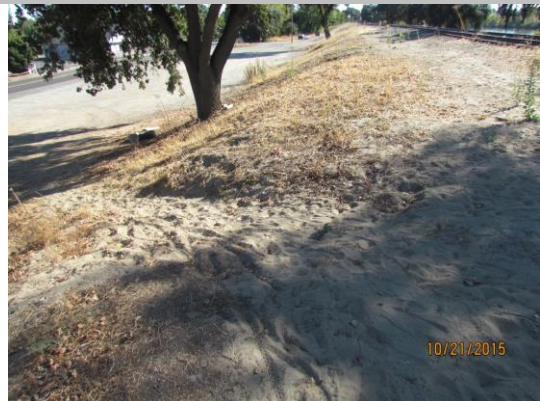
Photo 1 of 1 : SP\_2017\_MA0009\_201\_346\_20170320\_00264.jpg

View of the slope stability caused by foot traffic on the landward side of the levee looking downstream. Fall 2015.

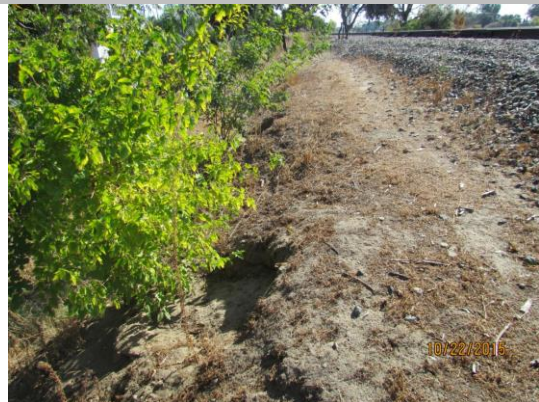
Photo 1 of 1 : SP\_2017\_MA0009\_201\_350\_20170320\_00266.jpg

View of the erosion on the landward side of the levee looking downstream. Fall 2015.

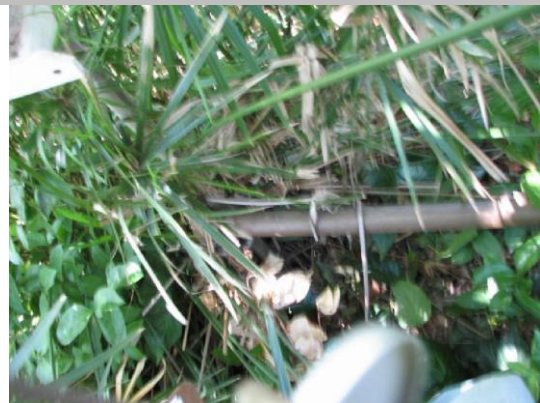
Photo 1 of 3 : UCIP\_SP\_2017\_5107\_6816.jpg

Pipe on WS slope just upstream from stairs.

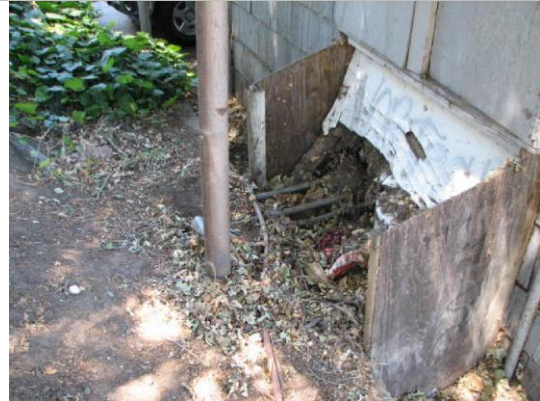
Photo 1 of 1 : UCIP\_SP\_2017\_5108\_6817.jpg

Pipes appear to be exiting the back of the shed and going through the levee at the LS toe.

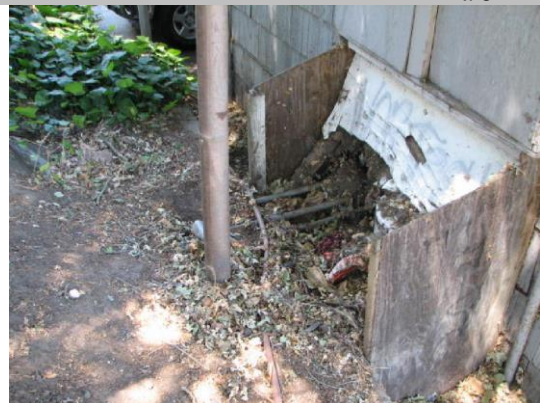
Photo 1 of 1 : UCIP\_SP\_2017\_5109\_6818.jpg

Pipes appear to exit the back of the shed and enter the levee.

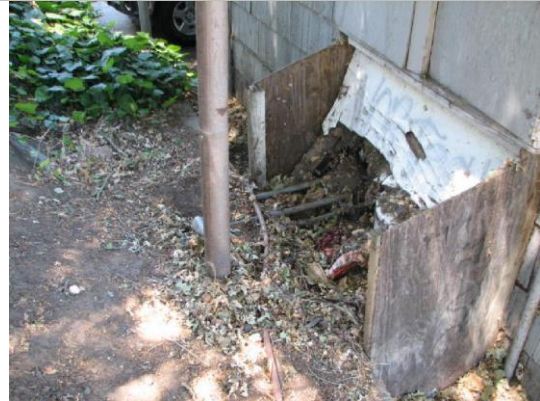
Photo 1 of 1 : UCIP\_SP\_2017\_5110\_6819.jpg

Pipes appear to exit the back of the shed at the LS toe and enter the levee.

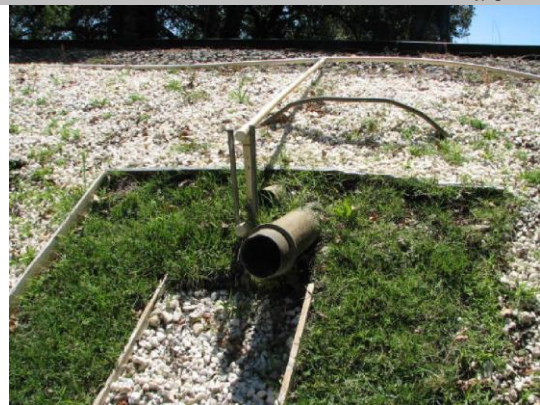
Photo 1 of 3 : UCIP\_SP\_2017\_51247\_20793.jpg

Pipe through freeport marina grass sign.

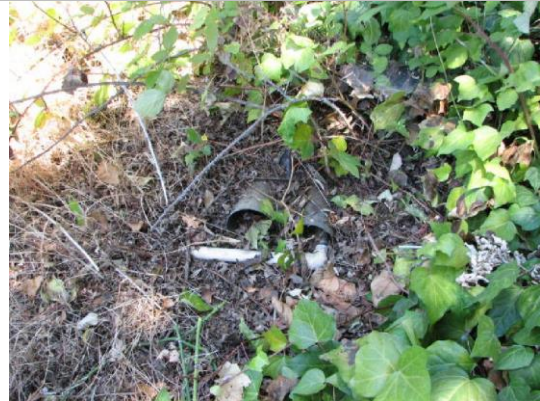
Photo 3 of 3 : UCIP\_SP\_2017\_51248\_20794.jpg

both pipes on WS shoulder.

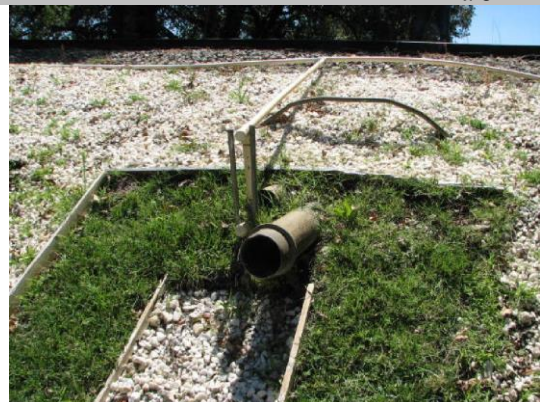
Photo 1 of 1 : UCIP\_SP\_2017\_5112\_6821.jpg

bent metal pipe at center leads to spigot at other end of Freeport Marina grass and gravel sign.

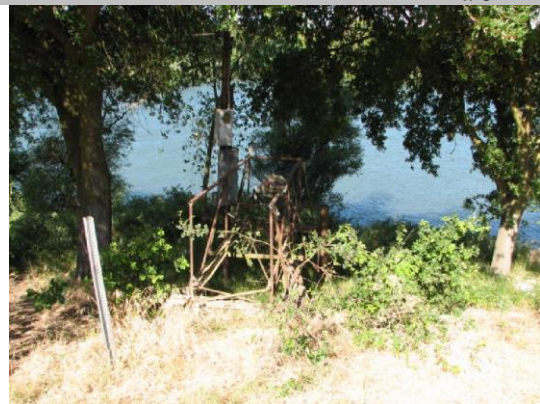
Photo 1 of 3 : UCIP\_SP\_2017\_5117\_6830.jpg

Walkway in total disrepair at pump on WS.

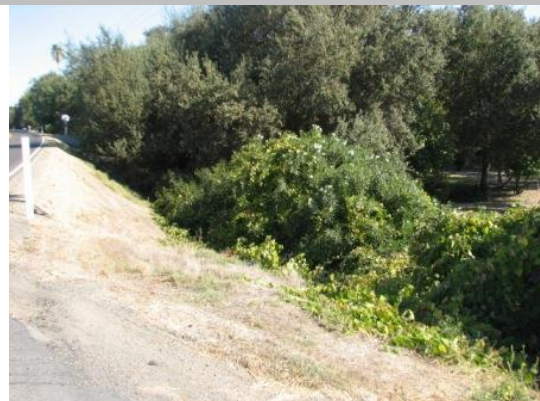
Photo 1 of 2 : SP\_2017\_MA0009\_201\_220\_20170320\_00177.jpg

The over grown landscape blocks visibility. Fall 2013

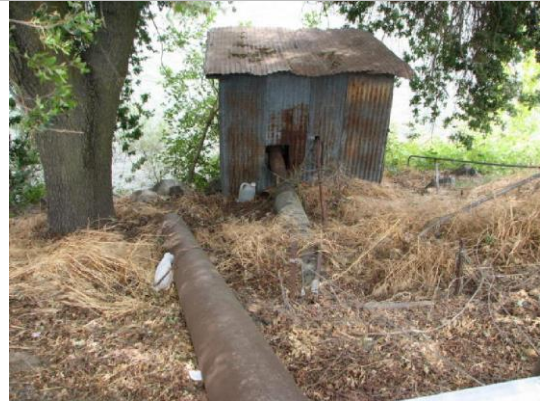
Photo 3 of 3 : UCIP\_SP\_2017\_5129\_6859.jpg

pipe and pumphouse on WS slope

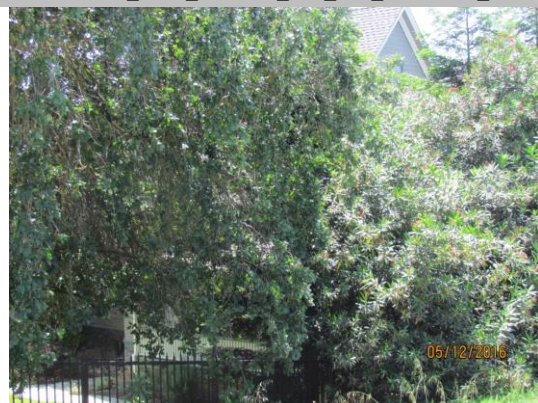
Photo 1 of 1 : SP\_2017\_MA0009\_201\_210\_20170320\_00172.jpg

View of the building on the landward side of the levee. The building is behind the shrubs and at the toe of the levee. Spring 2016.

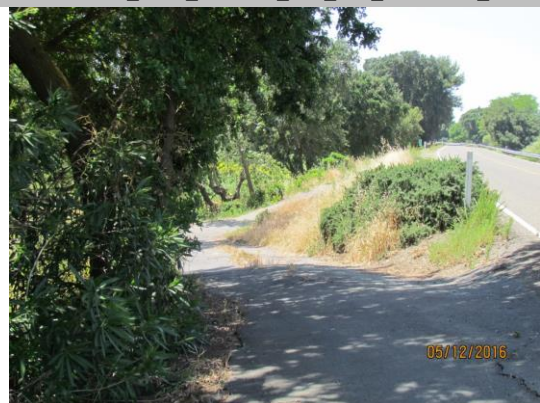
Photo 1 of 1 : SP\_2017\_MA0009\_201\_208\_20170320\_00170.jpg

View of the bush on the landward side of the levee looking downstream.  
Spring 2016.

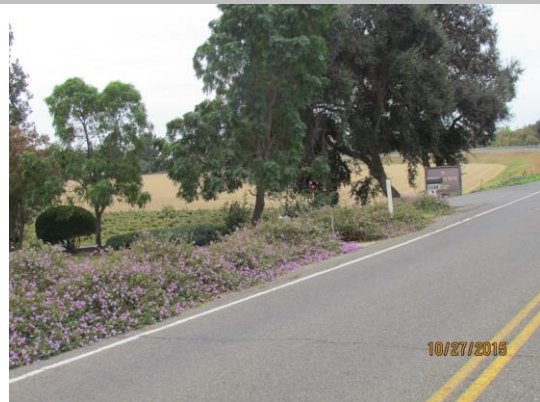
Photo 1 of 1 : SP\_2017\_MA0009\_201\_225\_20170320\_00179.jpg

View of the groundcover on the landward side of the levee looking downstream. Fall 2015.

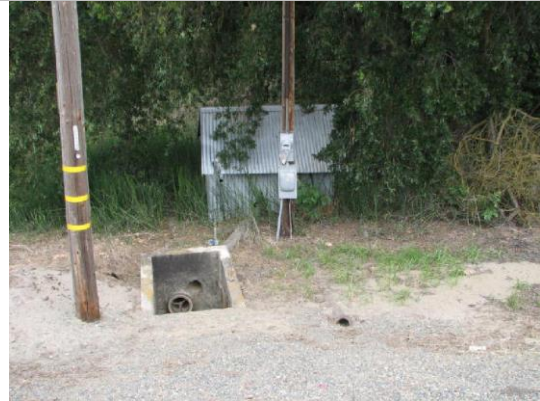
Photo 1 of 3 : UCIP\_SP\_2017\_51251\_20789.jpg

Pumphouse on LS toe with meter on pole and 3X5 concrete distribution box.

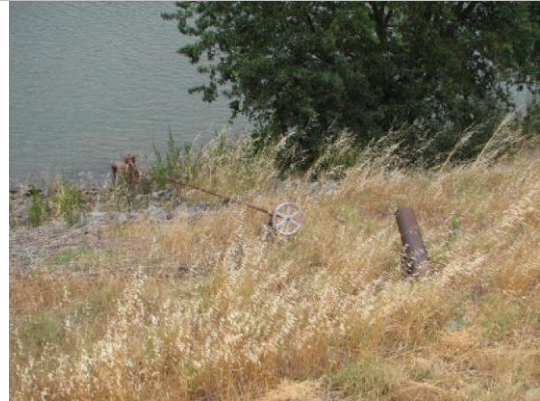
Photo 2 of 3 : UCIP\_SP\_2017\_51251\_20788.jpg

Remote hand crank for gate valve at WS toe.

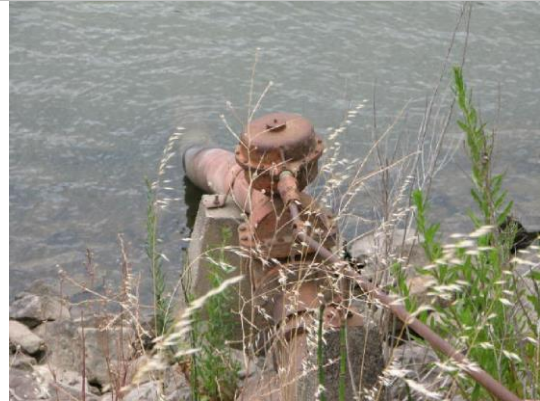
Photo 3 of 3 : UCIP\_SP\_2017\_51251\_20787.jpg

Gate valve at WS toe.

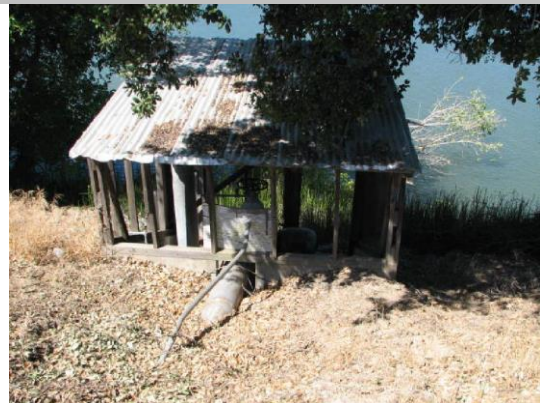
Photo 1 of 3 : UCIP\_SP\_2017\_5172\_6983.jpg

Pump and gate valve in pumphouse on WS slope.

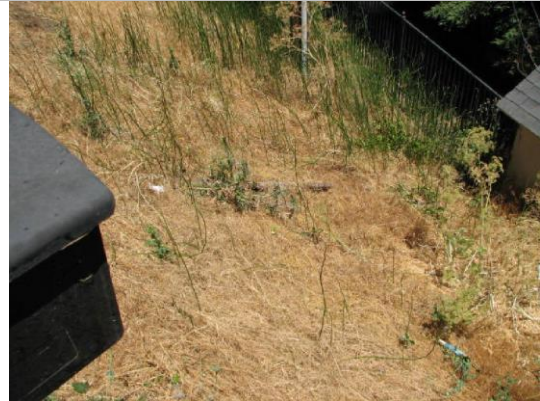
Photo 3 of 3 : UCIP\_SP\_2017\_51462\_20804.jpg

LS slope at pipe and pumphouse

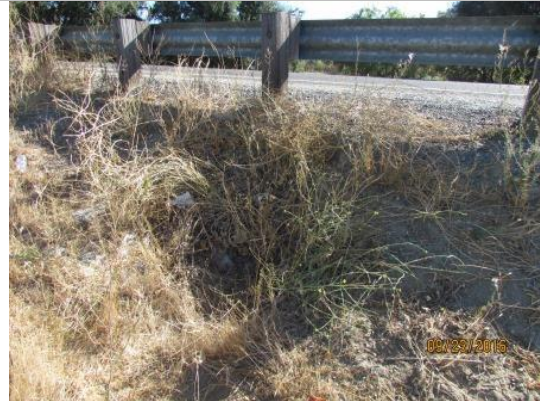
Photo 1 of 1 : SP\_2017\_MA0009\_201\_256\_20170320\_00200.jpg

At least 1-foot-deep cave found near a UCIP pipe on WS slope. Fall 2016.

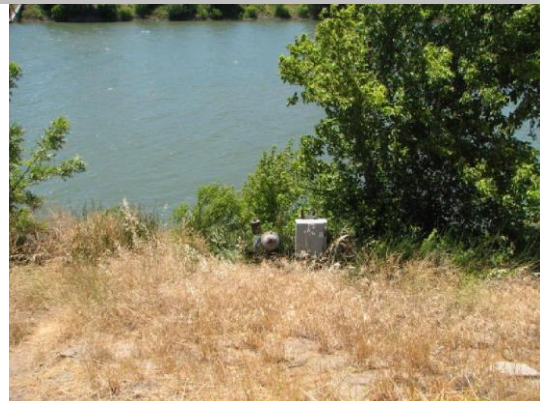
Photo 1 of 3 : UCIP\_SP\_2017\_51465\_20809.jpg

Slant pump on WS slope.

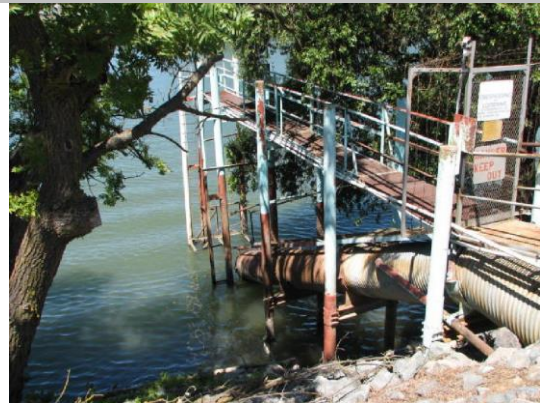
Photo 1 of 3 : UCIP\_SP\_2017\_51466\_20815.jpg

Pipe under pier.

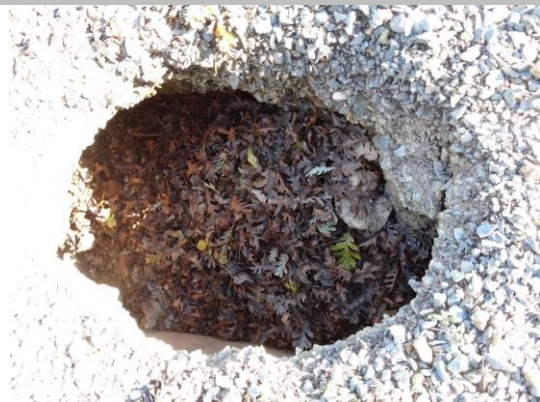
Photo 3 of 3 : UCIP\_SP\_2017\_51466\_76373.jpg

WS view: 2.5-feet by 3-feet sink hole present on WS.

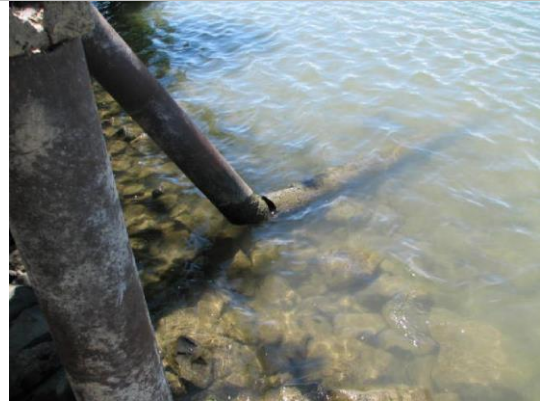
Photo 3 of 3 : UCIP\_SP\_2017\_41064\_7275.jpg

Ruptured pipe in water at WS toe.

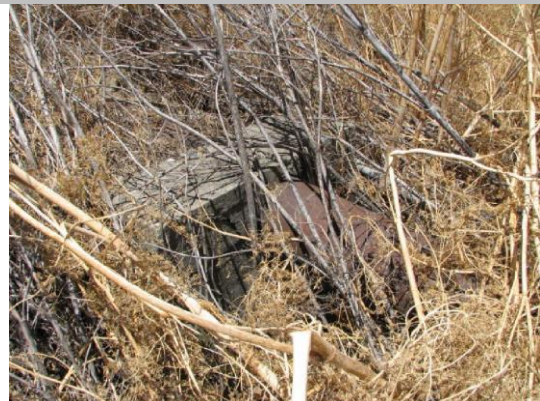
Photo 1 of 3 : UCIP\_SP\_2017\_5305\_7280.jpg

Pipe through concrete block on LS toe

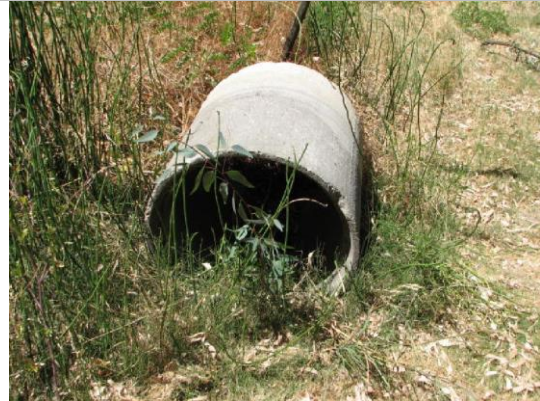
Photo 3 of 3 : UCIP\_SP\_2017\_5311\_7295.jpg

Remnants of 36-inch concrete standpipe on LS toe.

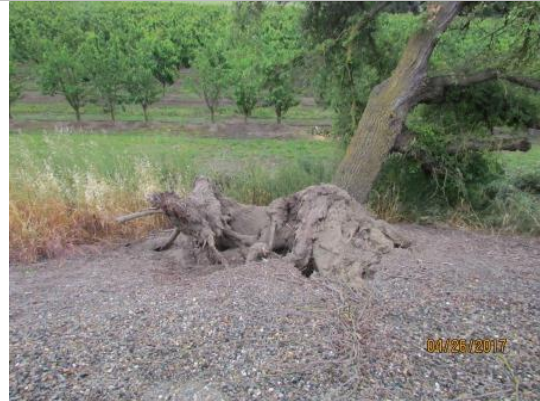
Photo 1 of 1 : SP\_2017\_MA0009\_201\_330\_20170426\_00511.jpg

View of fallen tree on landside levee slope. Spring 2017.

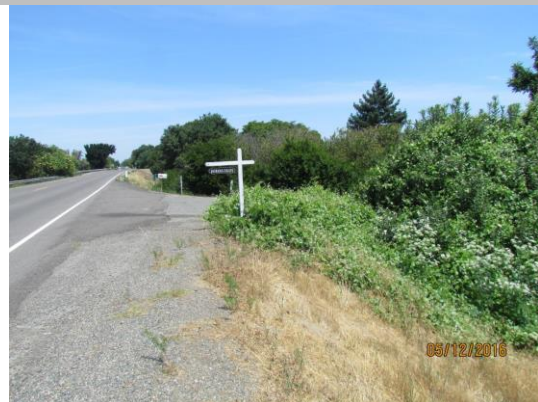
Photo 1 of 1 : SP\_2017\_MA0009\_201\_194\_20170320\_00158.jpg

View of the shrubs on the landward side of the levee looking upstream. Spring 2016.

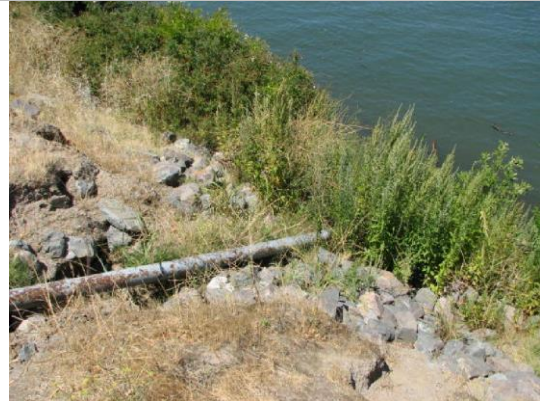
Photo 3 of 3 : UCIP\_SP\_2017\_5943\_9074.jpg

suction pipe on WS slope.
